PRD091 018622

Site Visit at Proteco

Ton H. Moy, Environmental Engineer  
NJ/Caribbean Compliance Section

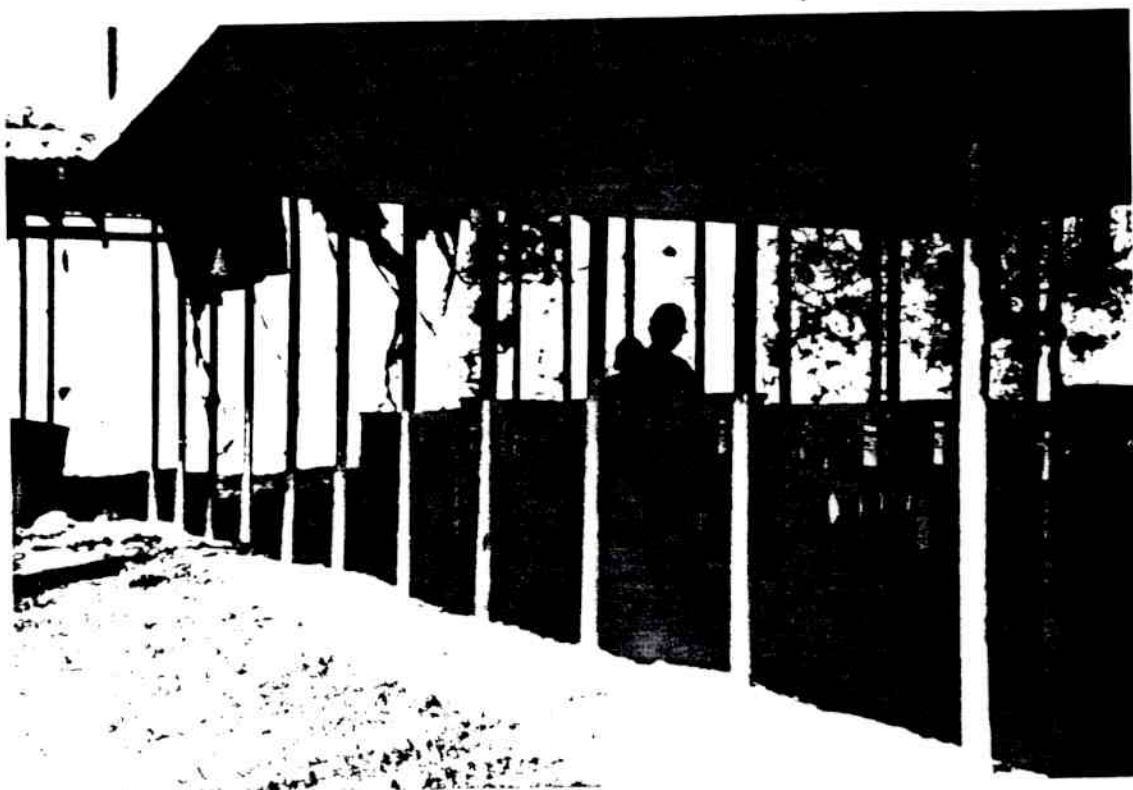
(1)

° The drum storage area is arranged in a U-shape configuration and stores nonhazardous waste as well as hazardous waste. It has a corrugated roof. The floor is "plain" soil and there is a small dike system constructed of soil around the storage area. The dike soil is loosely compacted. (For example, stepping on the "soil" dike would destroy its integrity.) There is no discernible "slope" to the floor, so if there was a release, one could not see it unless it was from the aisle drum. See photos # 1, 2, 3, 5, 7, 8, 13, & 14.

° The storage area does not have an impermeable base (this violation has been cited previously by EPA and EQB and has been included in our previous enforcement actions). See photos # 1, 2,

° Dike system to prevent run-on or run-off control is inadequate. See photos # 1, 2, & 3.

2) With respect to the drum storage area, corrosion and bulginess appeared in some of the drums; an odor was noticed from certain sections of the drum storage area during our site visit; and the drum storage area is not maintained in a responsible manner. It is recommended that at the minimum all the drums in a poor condition should be removed and properly disposed, because it might endanger workers nearby (appro. 300 yards) at the non-hazardous waste units and the personnel inspecting the drum storage area.

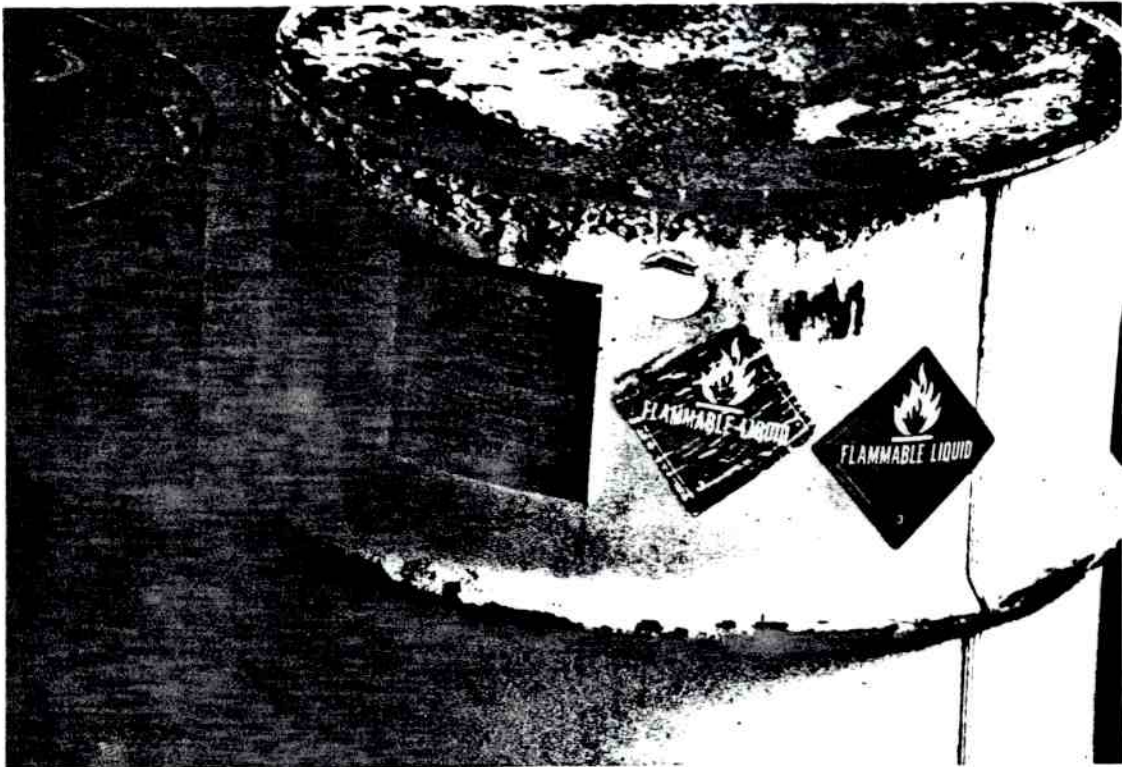
④

° Based on Rene, there were approximately 900 drums of hazardous waste and nonhazardous waste stored in the container storage area. These drums are mostly constructed of metal and plastic. Based on the records, Proteco has ceased accepting hazardous waste as of 5/1/90. See photos # 4, 6, 9, 10, 11, & 12.

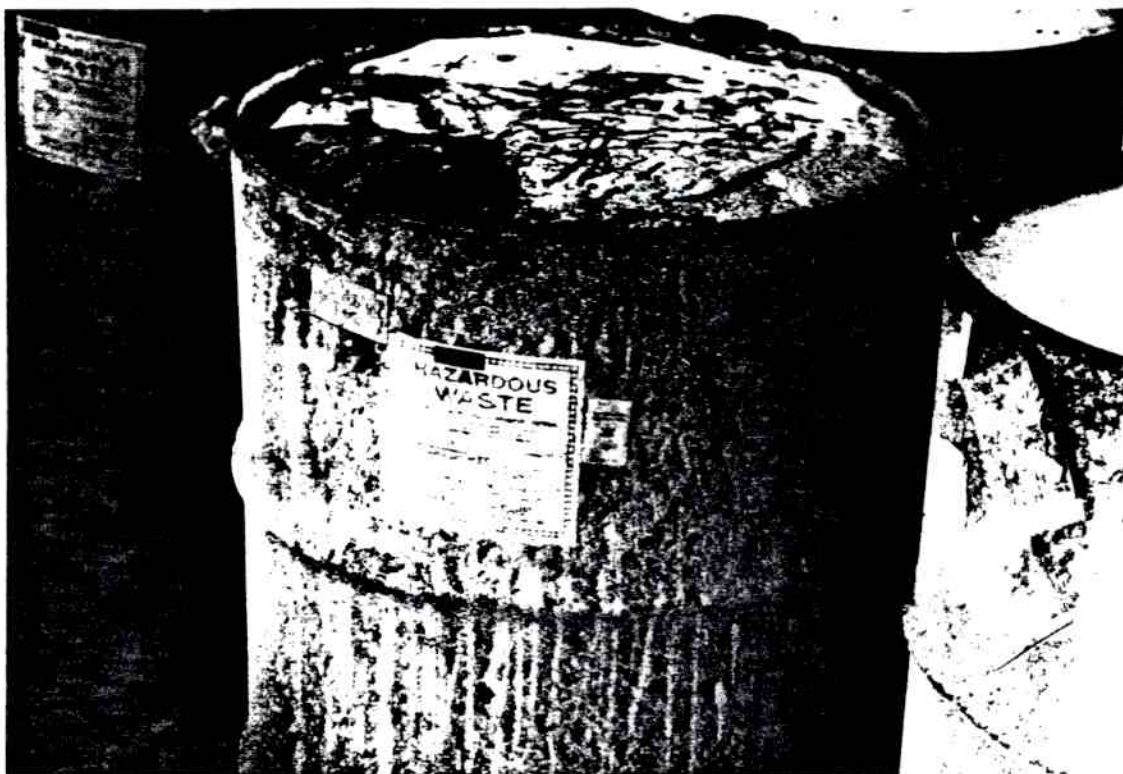
(9)

The labels on the drums were visible but some of the writing on the labels have faded and is difficult to read. See photos # 9 & 10.

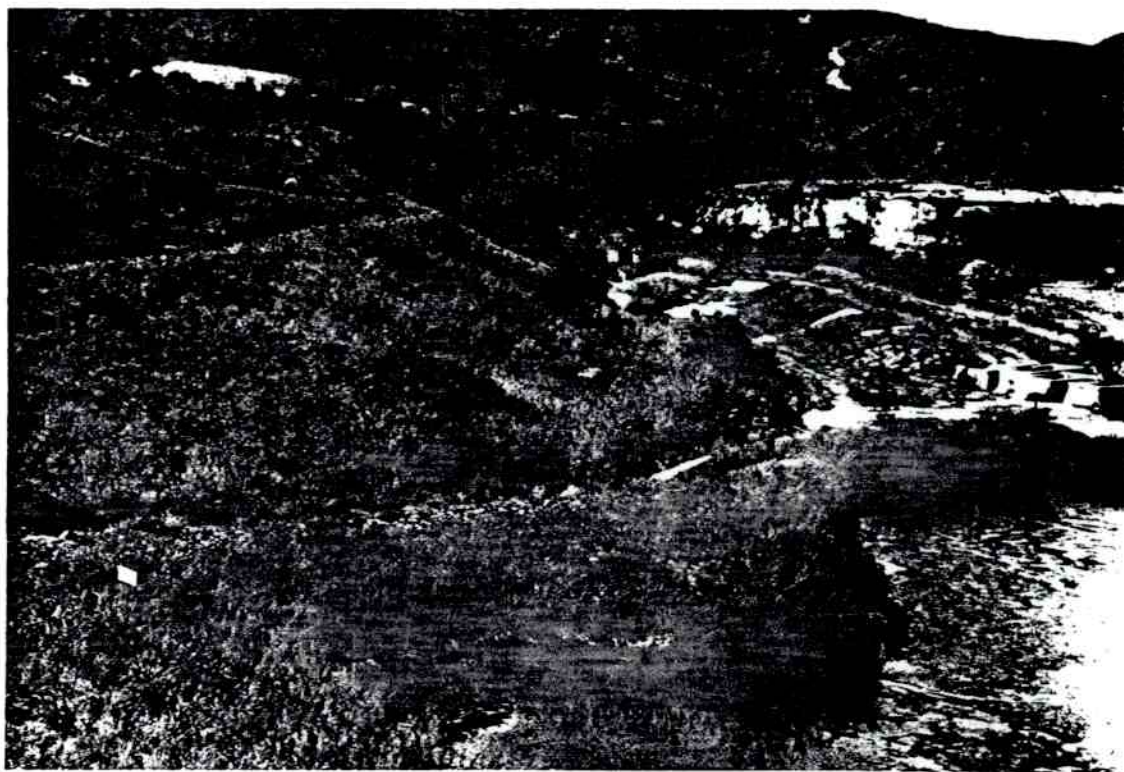
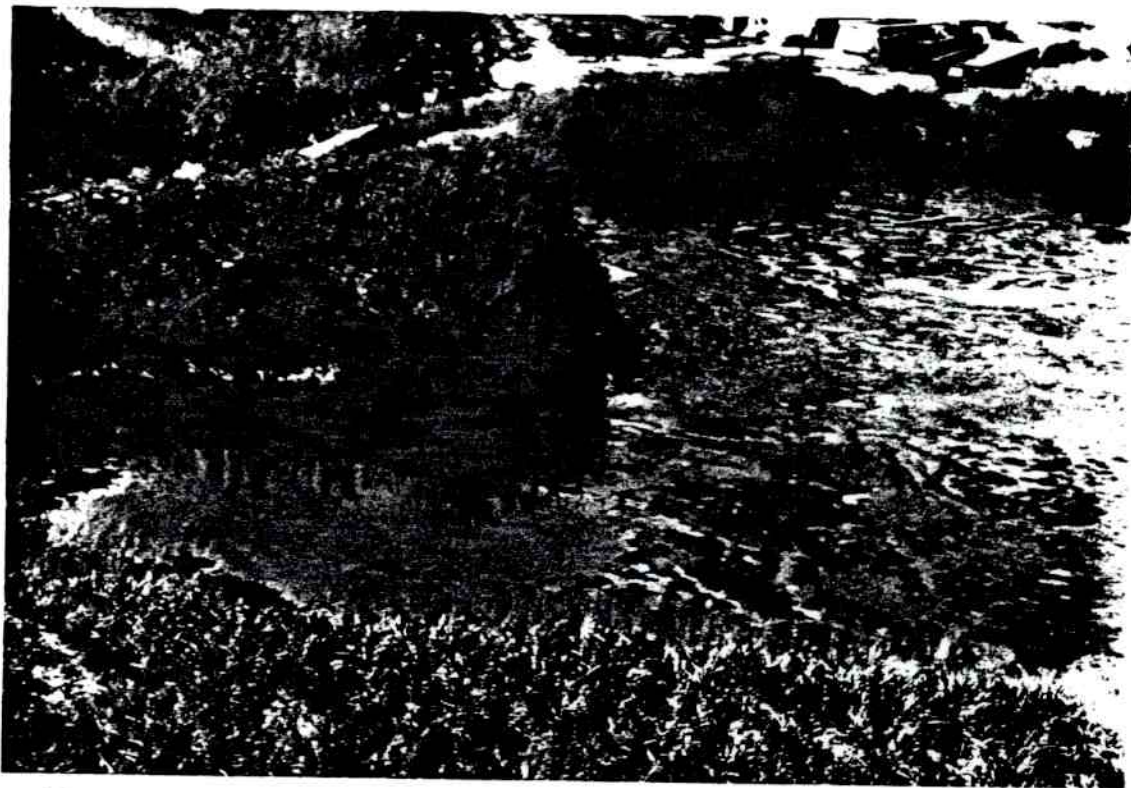
As indicated in the Part A and Part B applications, the existing oil lagoon has an area of 16,000 square feet and a total capacity of 5,925 cubic yards. See photos # 15, 16, 17, & 18. Proteco lost interim status for this unit on 11/8/85. This unit handled mainly waste oil, oil sludges, and ignitables. Some of the waste types handled were ignitable (D001), non-halogenated solvents (F005), ethyl acetate (U122), methanol (U154), and toluene (U220). During the Nov. 14-23, 1985 inspection, the records indicated that 132 lbs. of potassium cyanide (P098) was placed into oil lagoon on 10/11/85.

As indicated by Proteco, Safety Kleen has been collecting samples from this lagoon for the purpose of negotiating a possible agreement with Safety Kleen to remove the wastes, using the waste as a fuel for the cement kilns. Proteco, as of 10/31/91, has not yet removed and properly disposed of the hazardous waste from the oil lagoon and contaminated media associated with this lagoon.

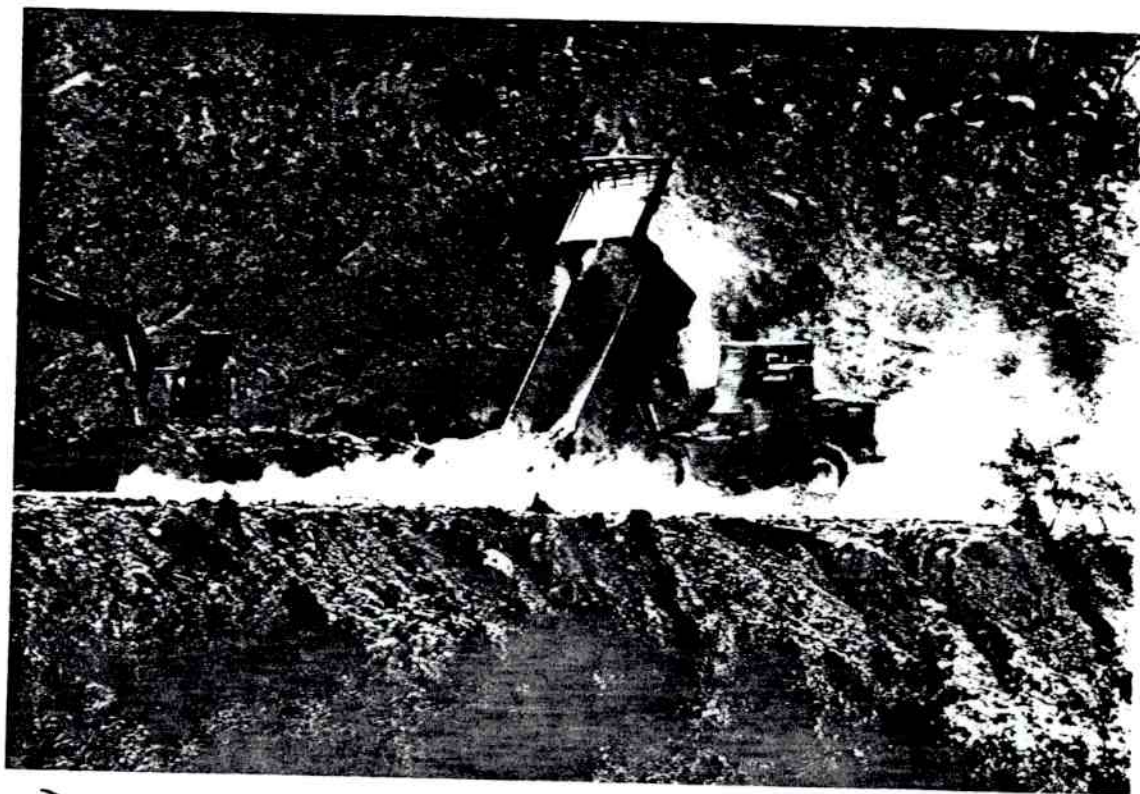
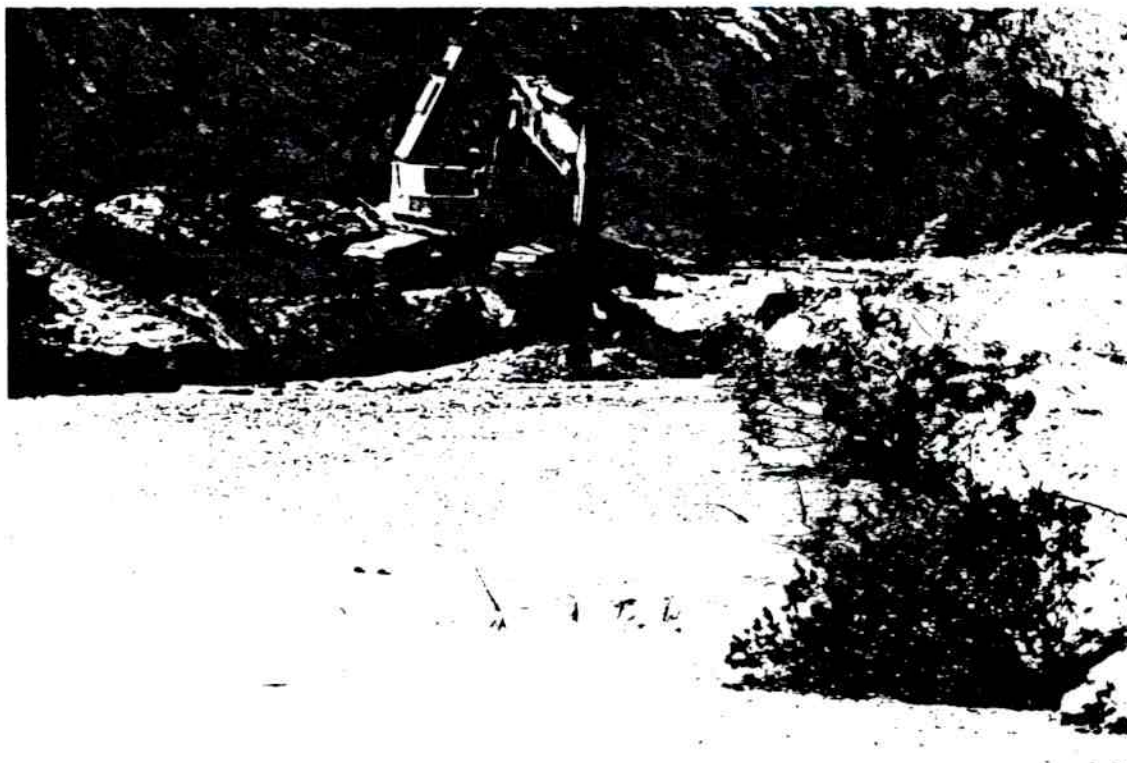
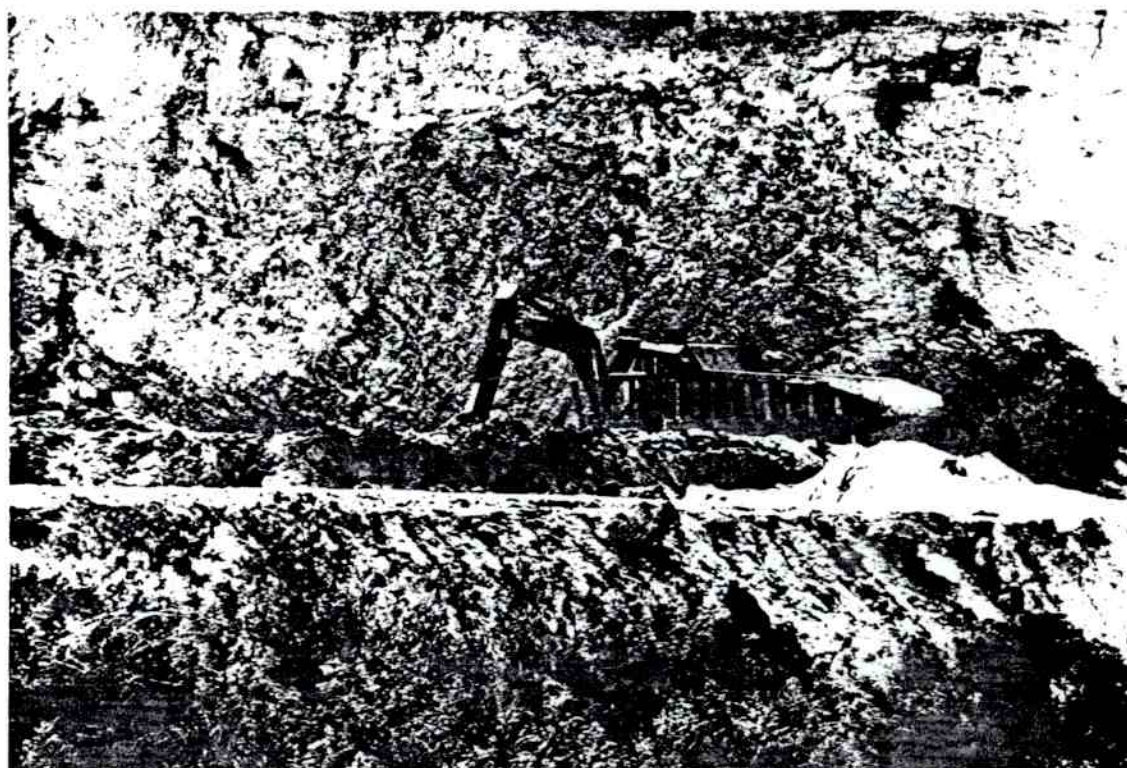
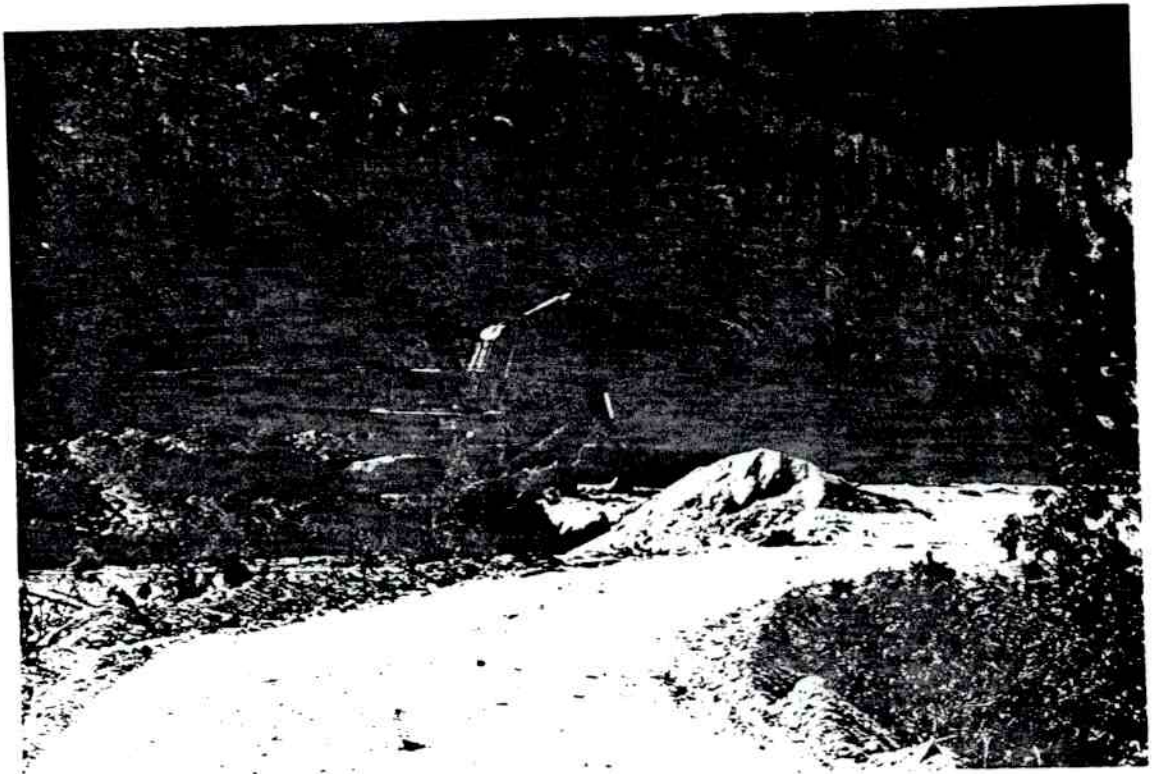
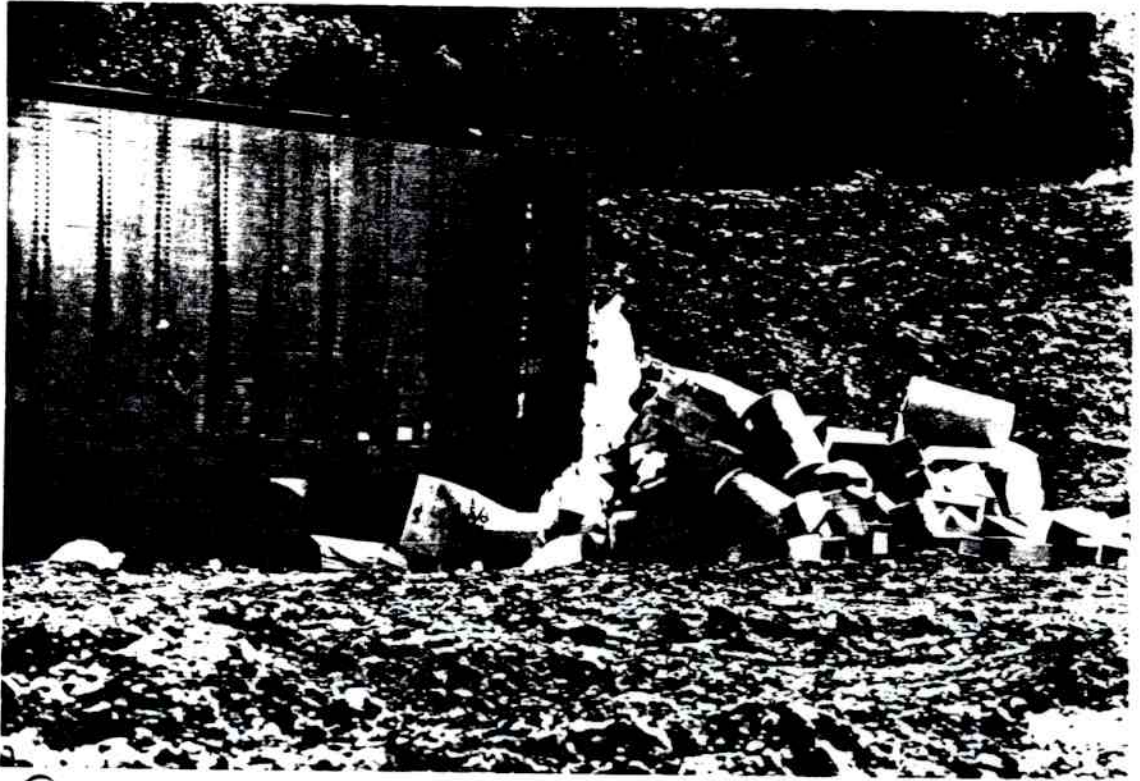
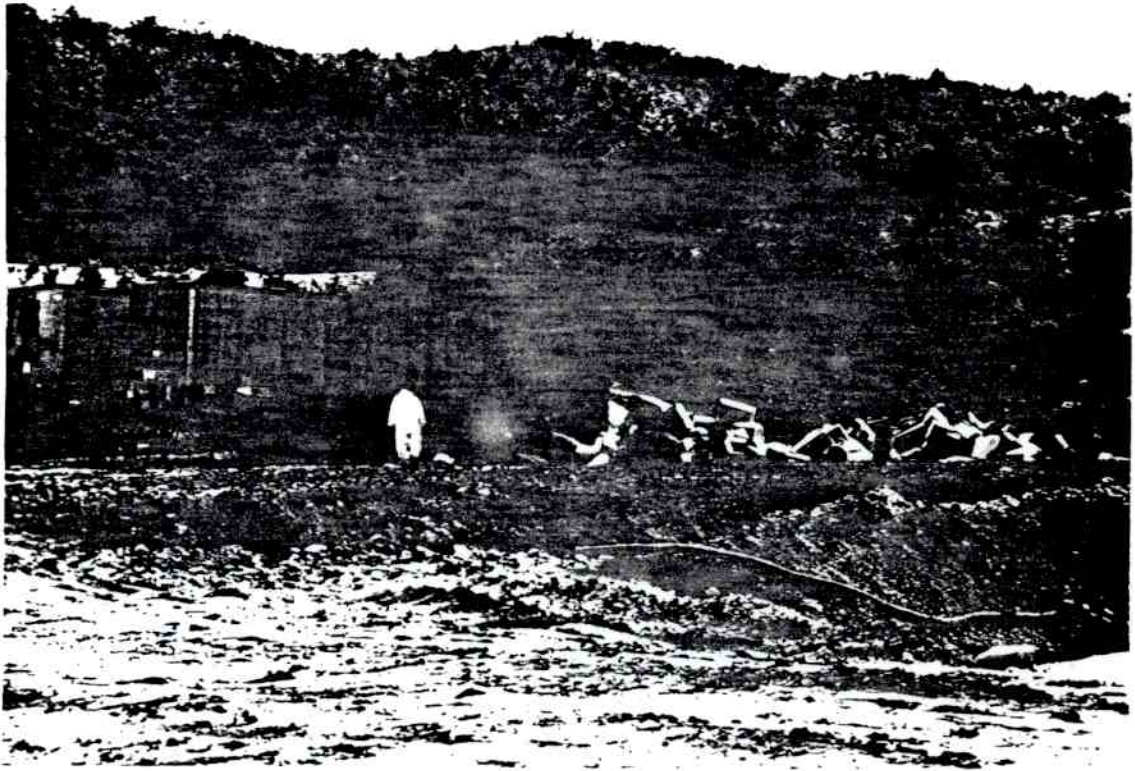
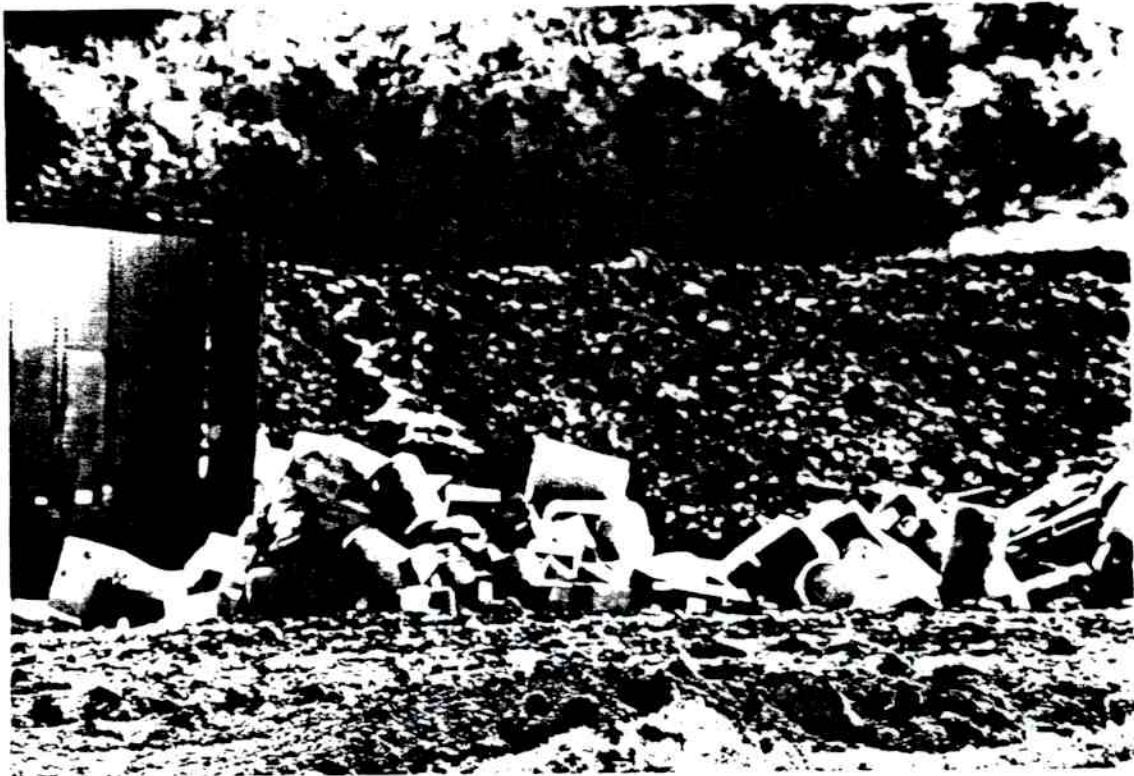
Proteco accepts solid waste for its non-hazardous waste landfills from many diverse manufacturing operations and/or institutions located in Puerto Rico. These landfills are operating under a permit issued by Puerto Rico Environmental Quality Board. See photos # 19, 20, 21, 22, 23, 24, 31, 32, & 33. There were heavy equipments (bull-dozer, backhoe, trucks) in operation.

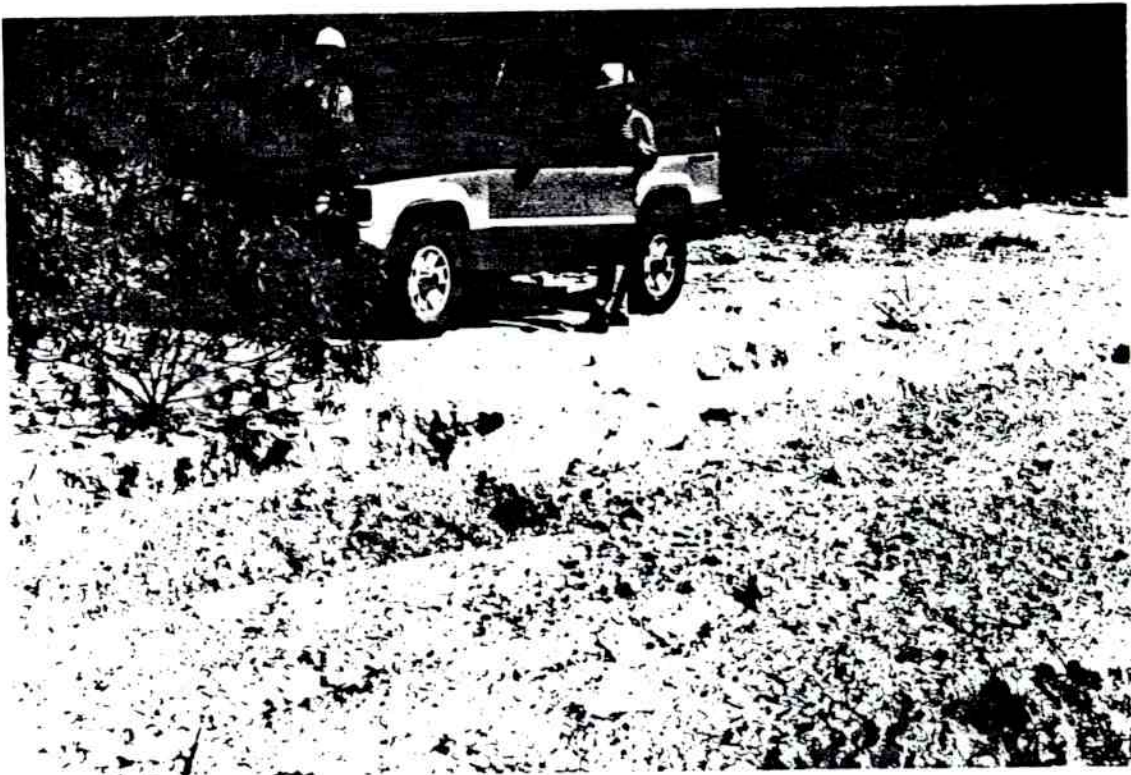
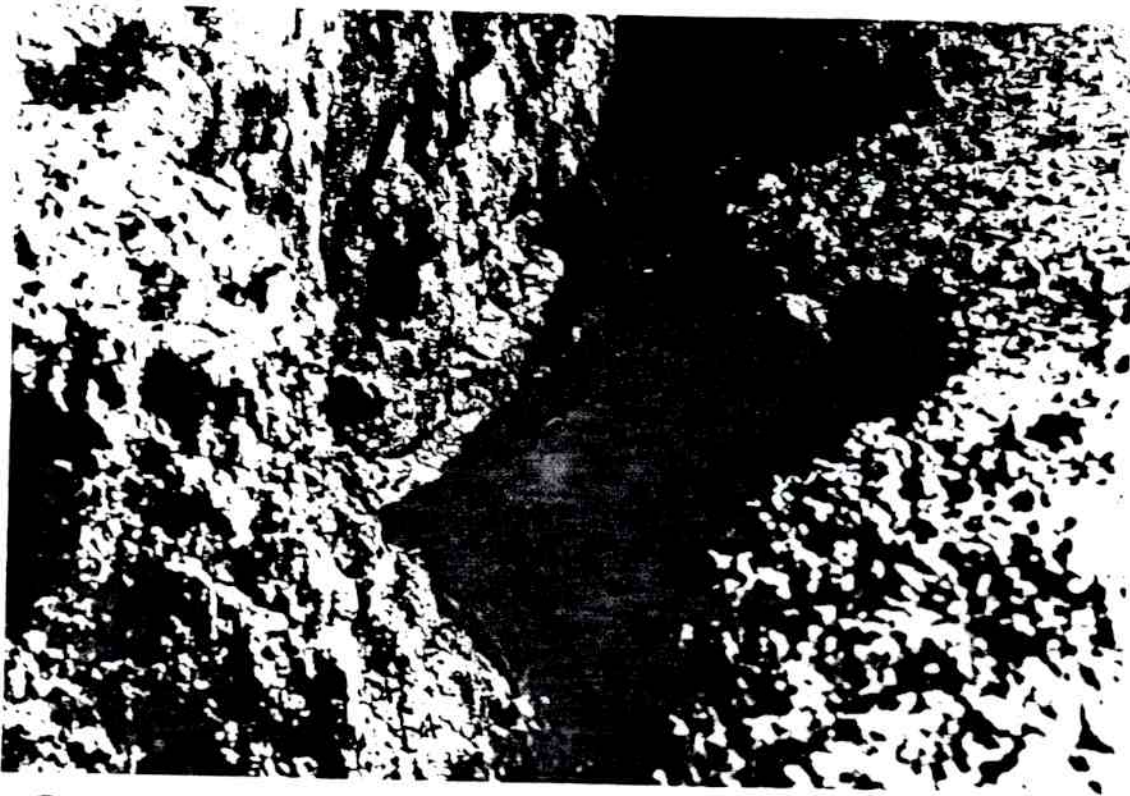
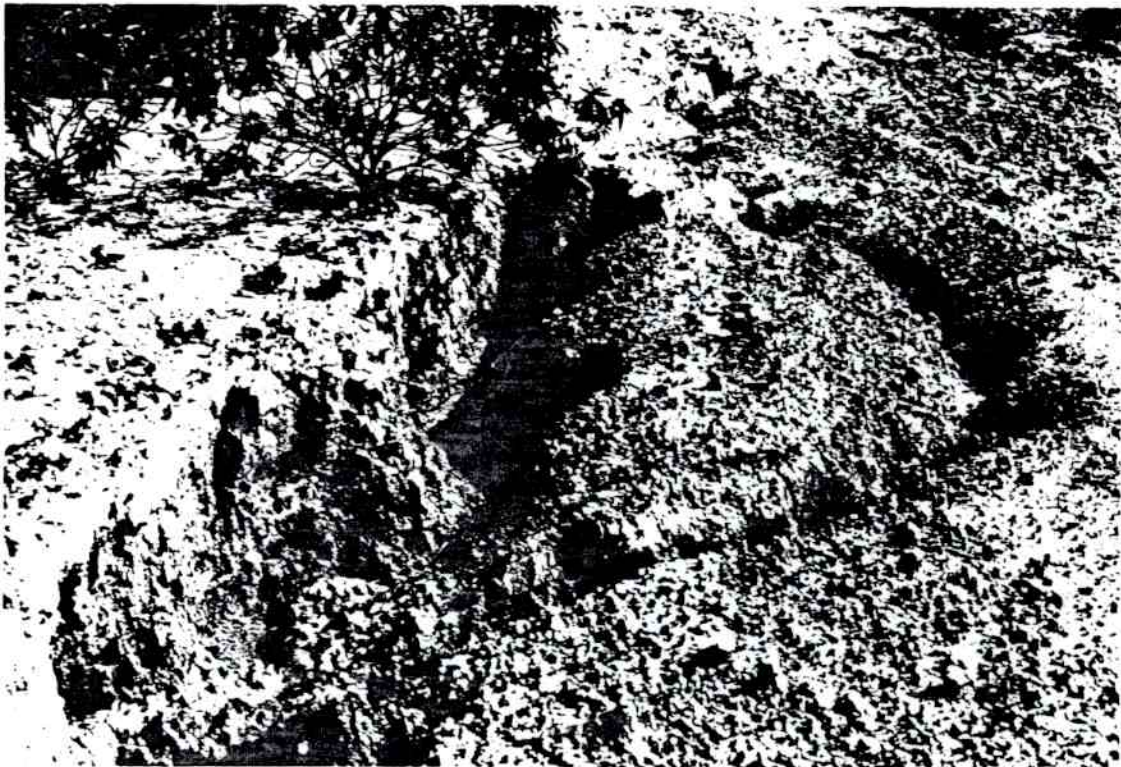
As we went along the road to Unit # 17 (the inactive and capped neutralization impoundment), the road was very "loose", with numerous "channels" carved into it (most likely caused by soil erosion or displacement) which made it difficult to walk on. See photos # 37, 38, 39, & 40. There is an embankment along the southern and eastern sides of the capped impoundment. We noticed "streamers" carved onto the embankment--most likely caused by soil erosion during precipitation. Precipitation is most likely to be accumulated in this disposal area. We did not see any trench system installed to divert collected precipitation. See photos # 41, 42, 43, & 44.

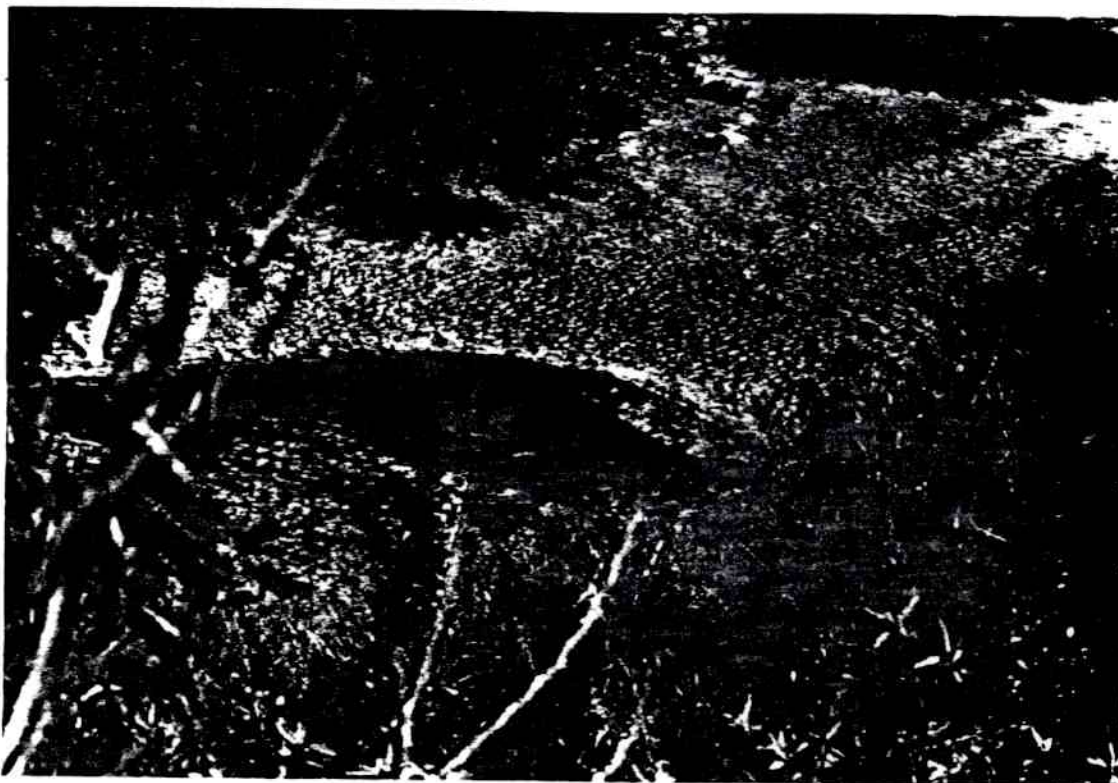
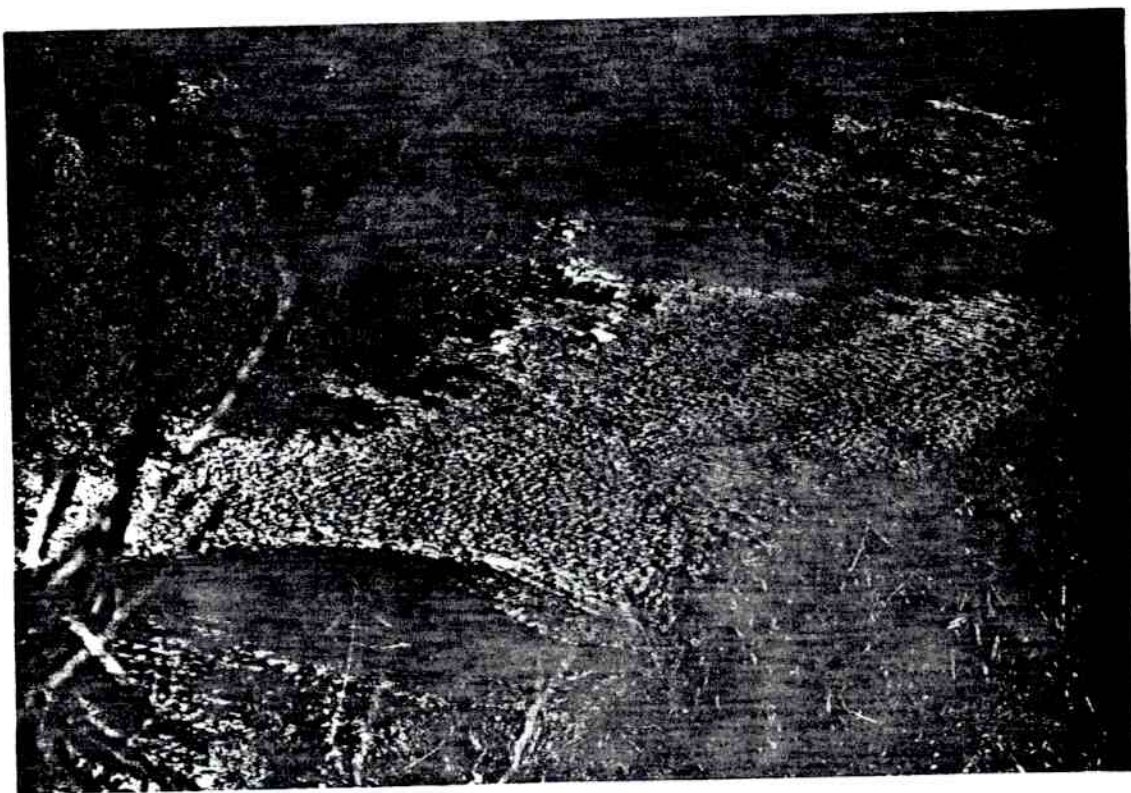
The rainwater basin was used as a holding basin for supernatant water collected in the oil lagoon. Looking down at the inactive rainwater lagoon, we noticed a discoloration of soil at the bottom of the lagoon. This discoloration could be caused by the supernatant water collected from the oil lagoon. See photos # 45 & 46.
